Project Name: Gold King Mine	Site Location: Silverton, San Juan County, Colorado	Project No. 0001/1408-01
--	---	------------------------------------

PHOTOGRAPH LOG

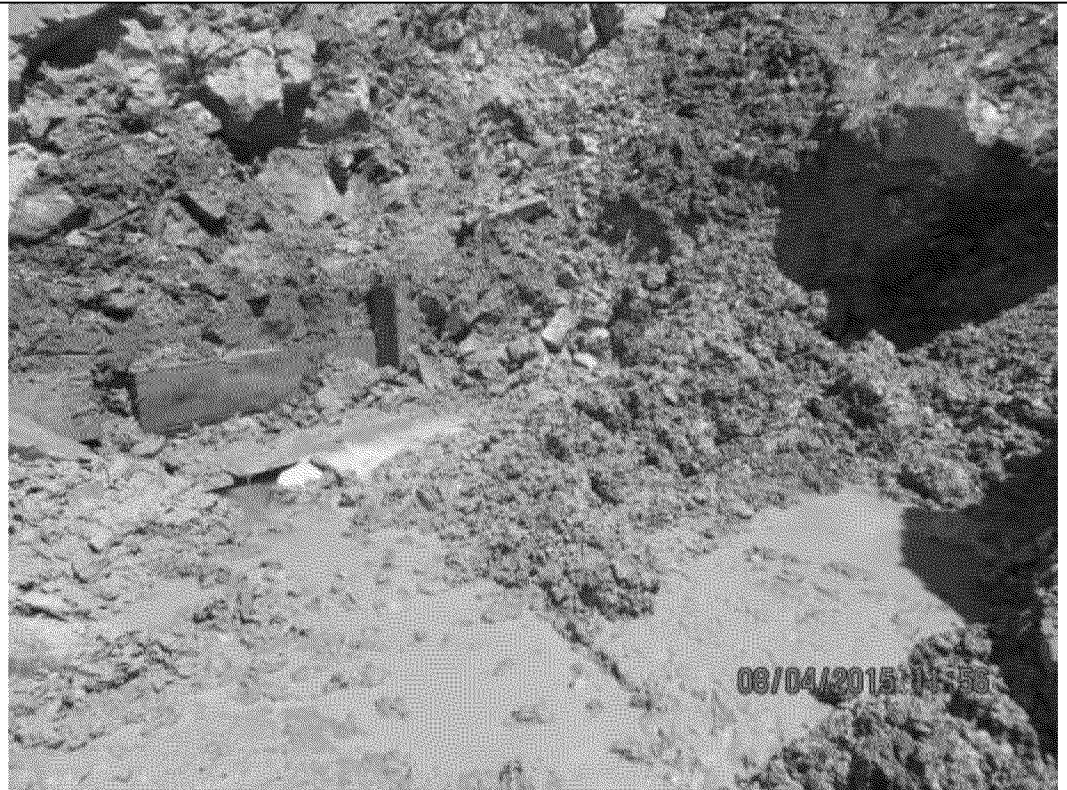
Photo No.
9

First signs of adit, support pillar with lagging.

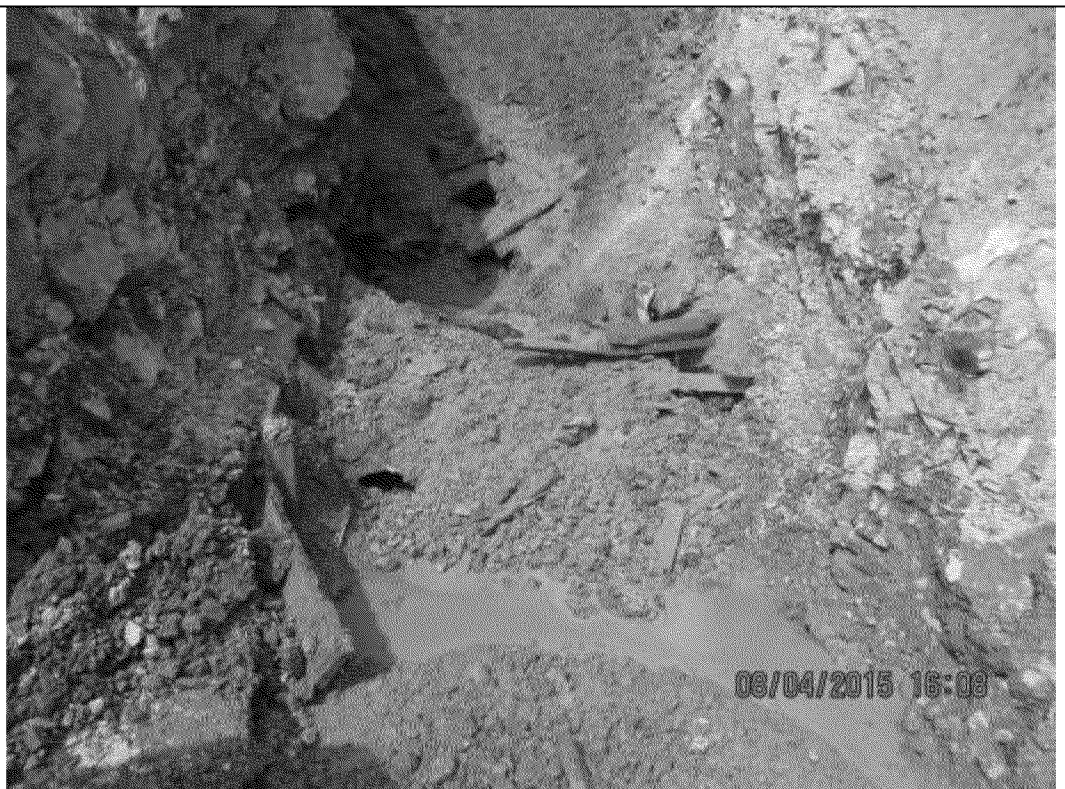
Photo No.
12

Collapsed supports uncovered above anticipated adit, no sign of bedrock above the adit area.

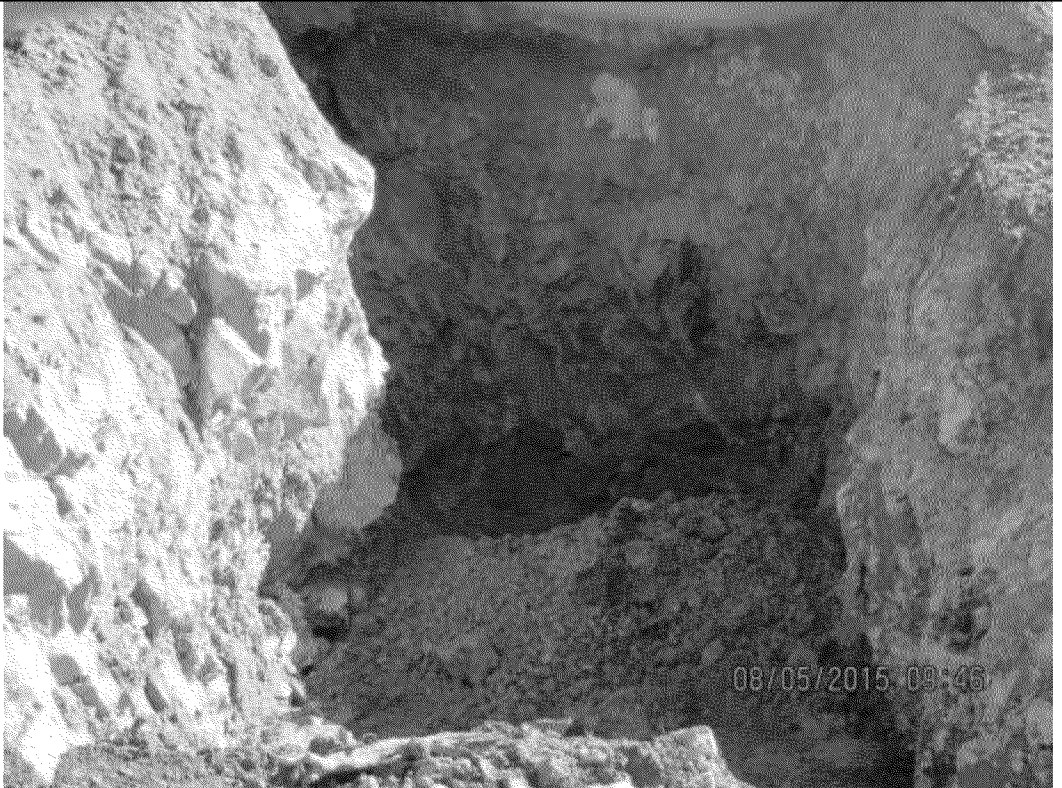
Photo No. 15	Date: 08/05/2015

Direction Photo Taken: North		
Description: Bedrock found above the anticipated adit.		
Photo No. 16	Date: 08/05/2015

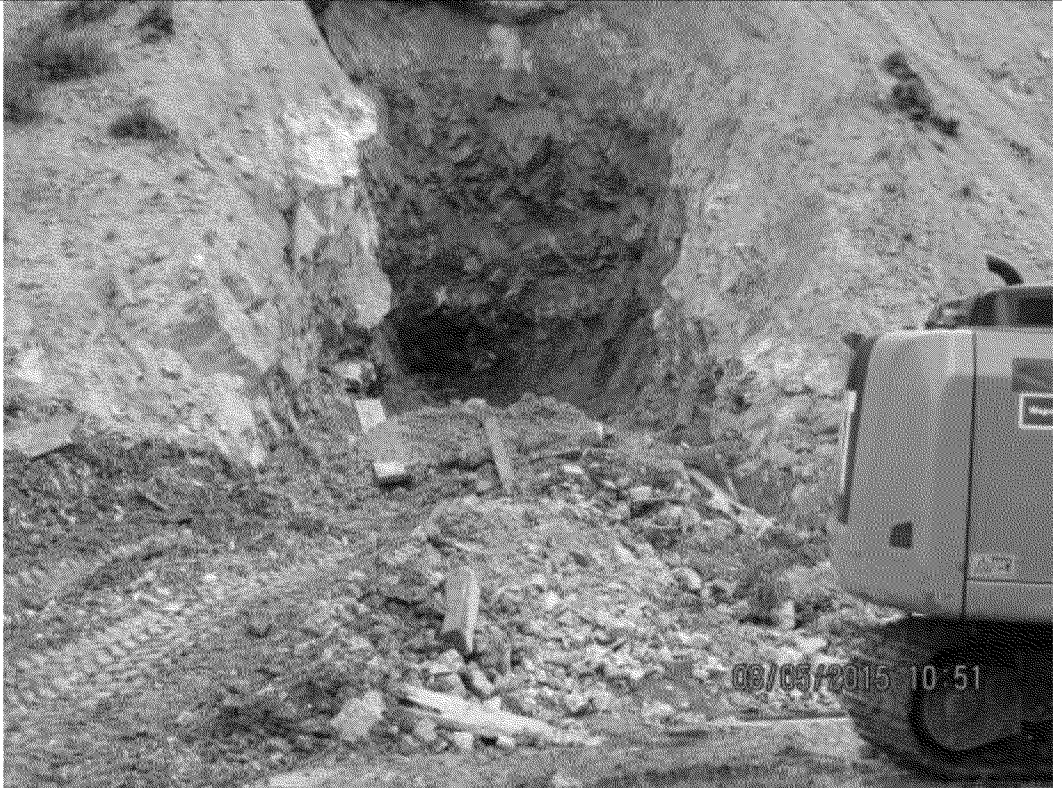
Direction Photo Taken: North		
Description: Cleaning out excavated material, small leak.

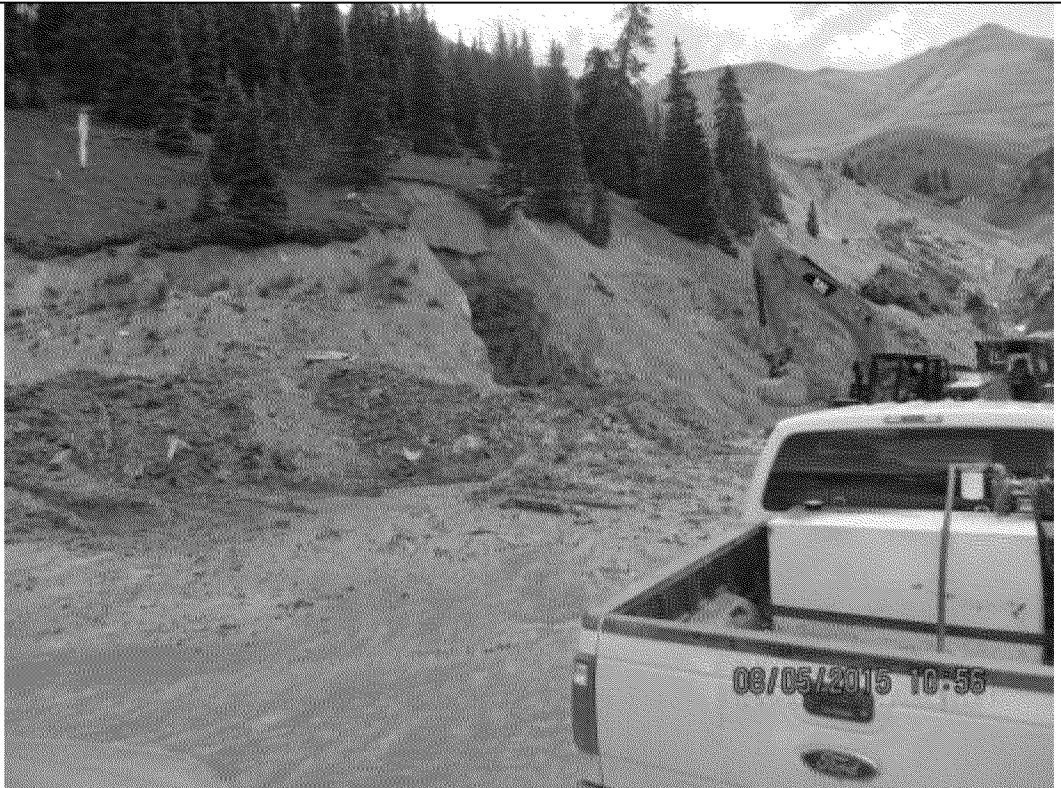
Photo No. 19	Date: 08/05/2015

Direction Photo Taken: Northeast		
Description: Adit flow increasing.

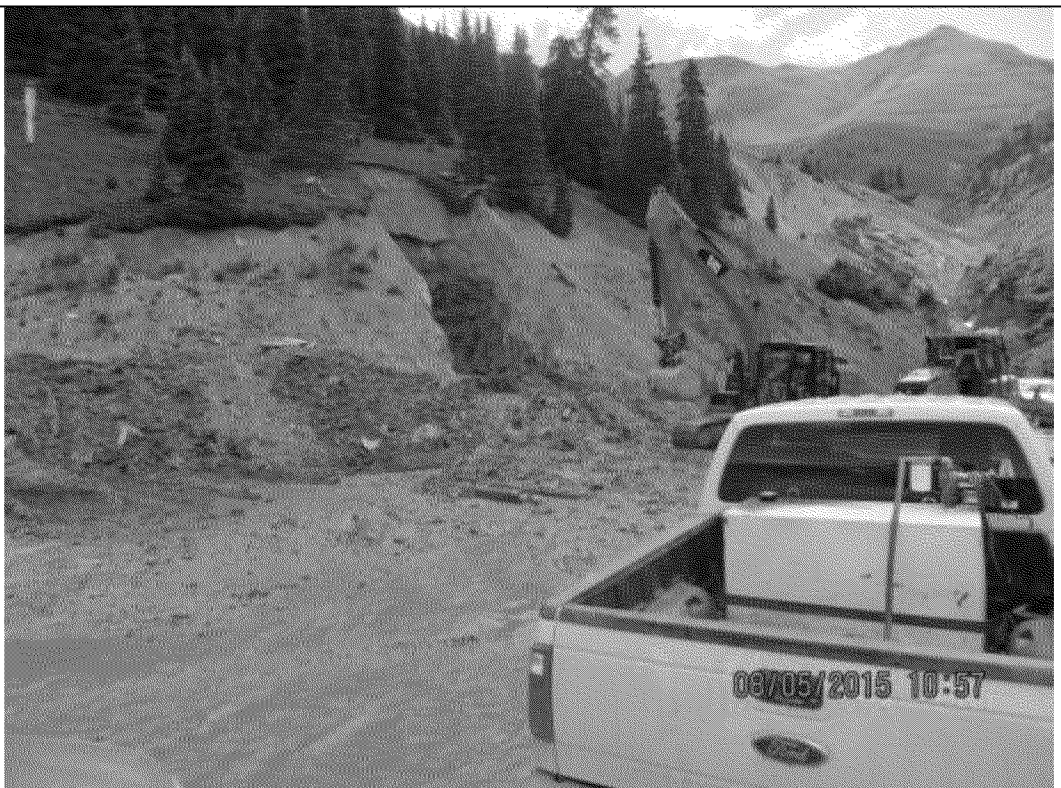
Photo No. 20	Date: 08/05/2015

Direction Photo Taken: Northeast		
Description: Water flooding out at increased rate.

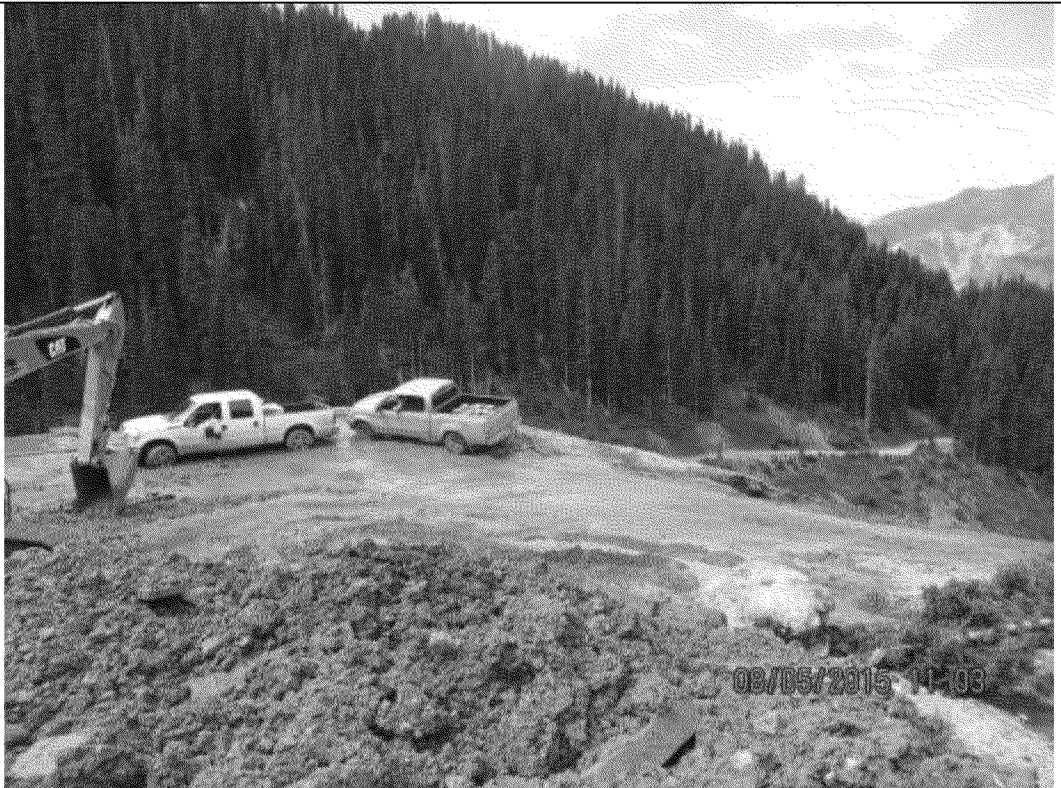
Photo No. 23	Date: 08/05/2015

Direction Photo Taken: Southwest		
Description: Exit route starting to collapse

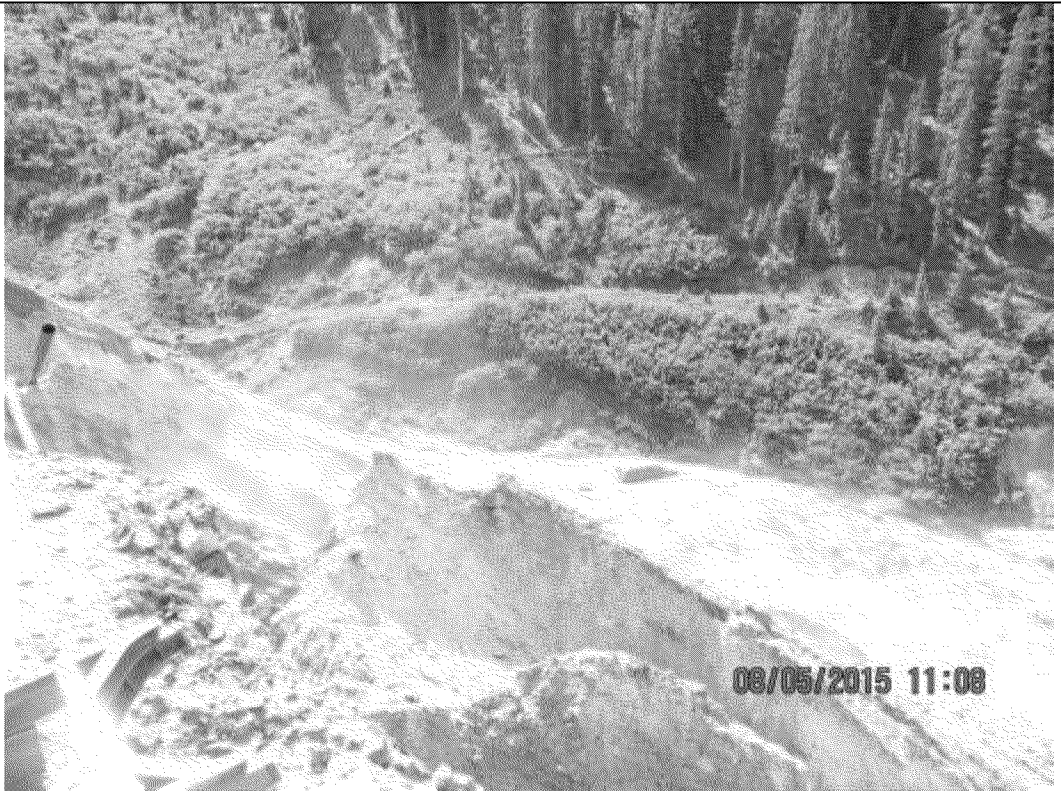
Photo No. 24	Date: 08/05/2015

Direction Photo Taken: Southeast/Down		
Description: Edge of the tailings dump collapsed, suburban trapped and half submerged in center of photo.

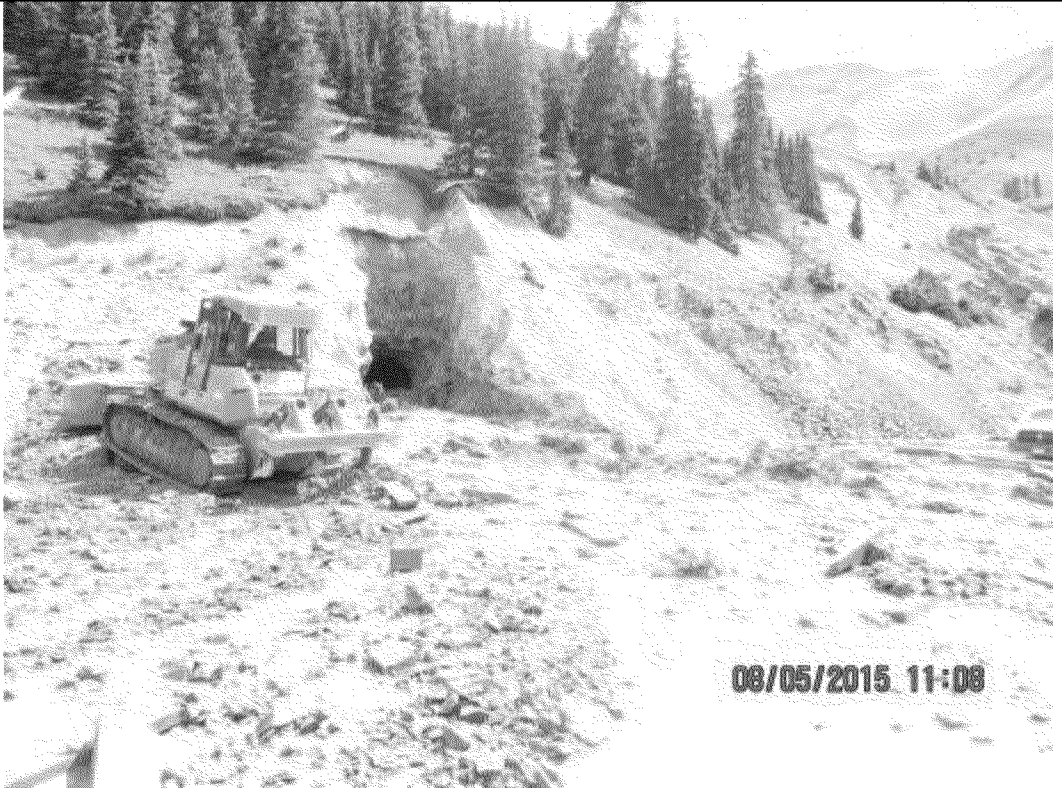
Photo No. 25	Date: 08/05/2015

Direction Photo Taken: Northeast		
Description: Gold King adit exposed.		
Photo No. 26	Date: 08/05/2015

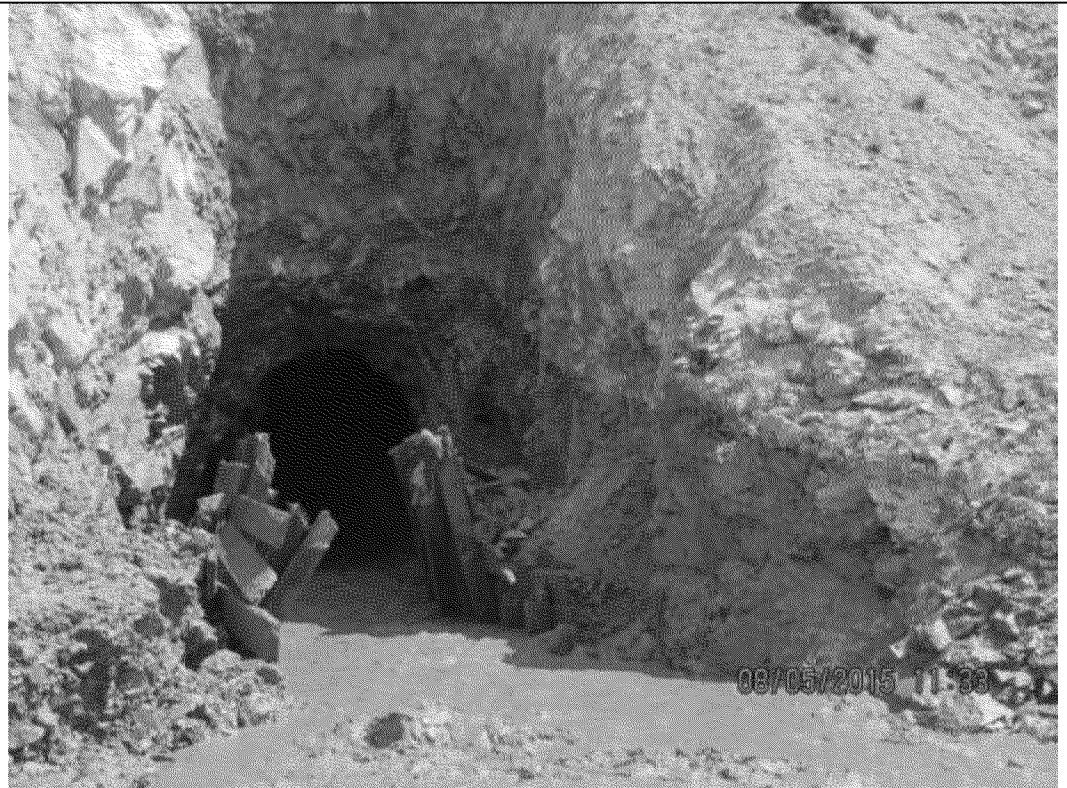
Photo No.
27

Exposed adit, roughly 10 feet wide by 15 feet high.

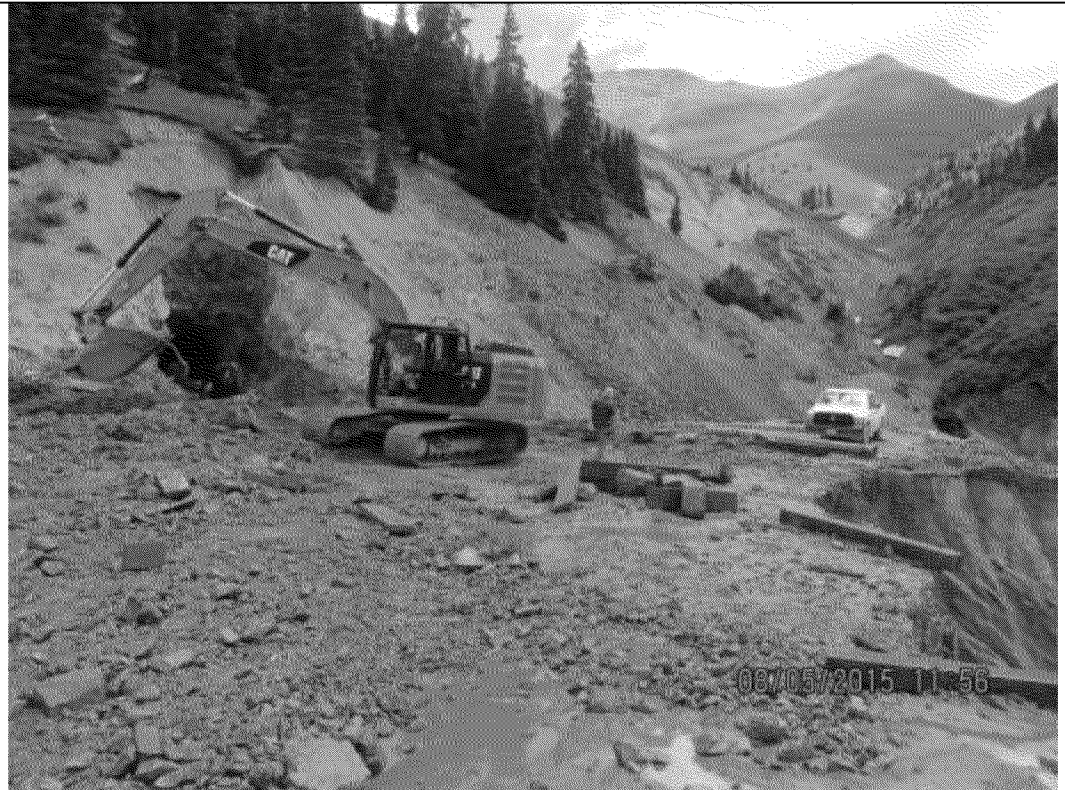
Photo No.
29

Excavator redirecting water into existing half-pipe channel.

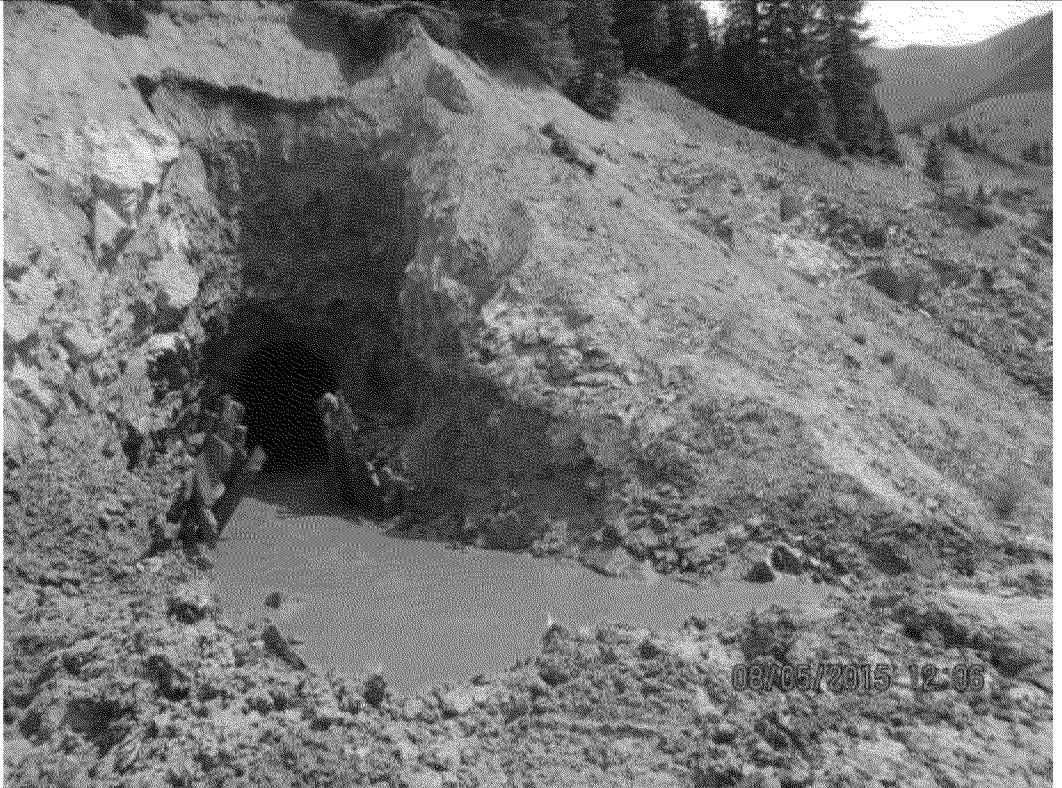
Direction Photo Taken: North		
Description: Exposed adit and redirected flow, flow is beginning to subside.

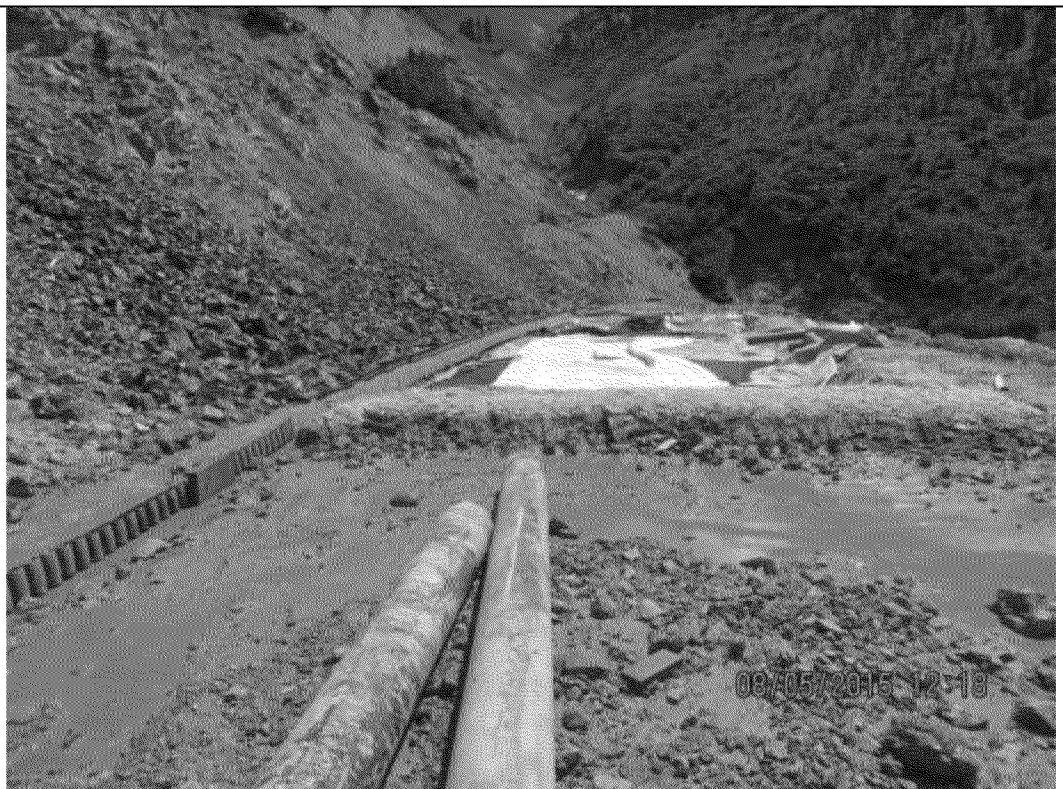
Photo No.
36

Existing flow channel at maximum capacity.

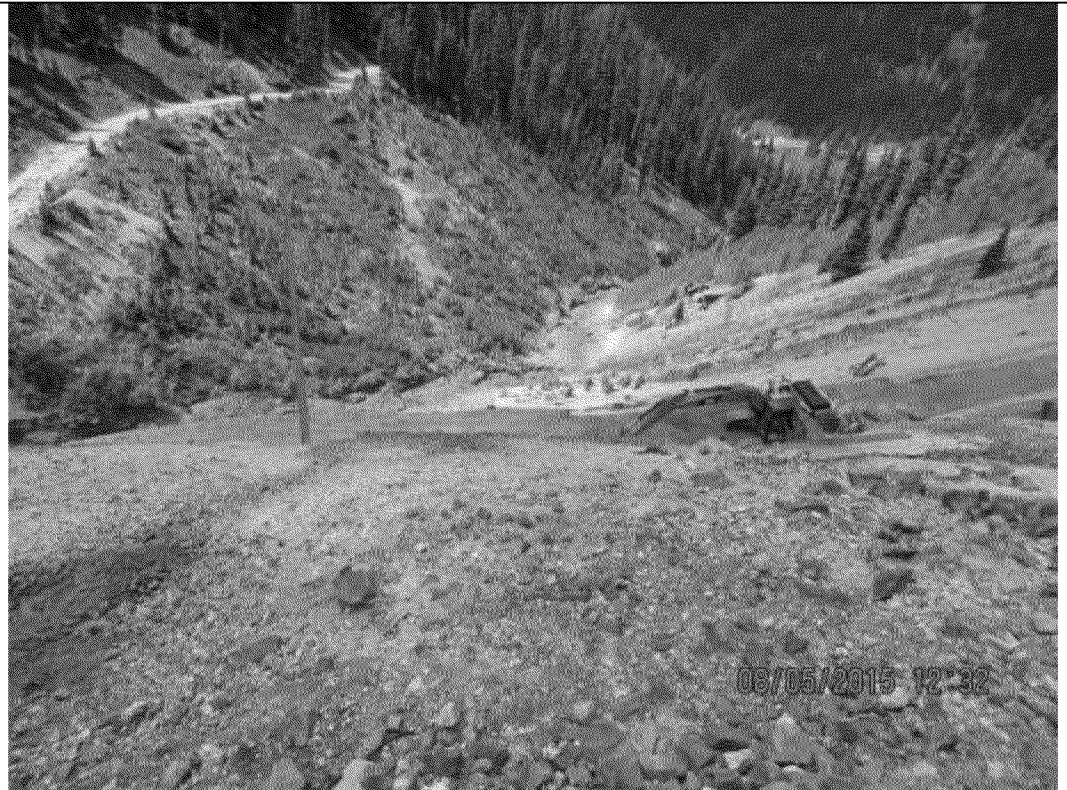
Photo No.
37

Excavator progress on fixing access road to create a safe exit route.

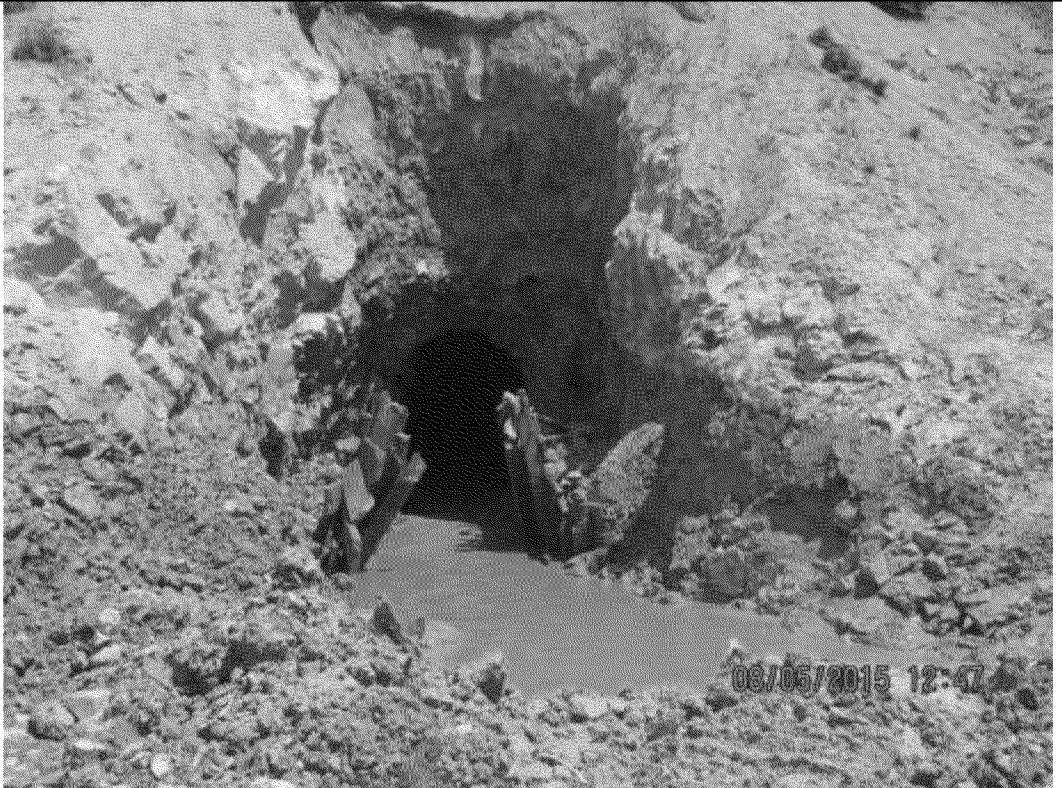
Photo No. 39	Date: 08/05/2015

Direction Photo Taken: North		
Description: No changes visible in adit structure or supports. Sloughing of materials inside the mine can be heard.		
Photo No. 40	Date: 08/05/2015

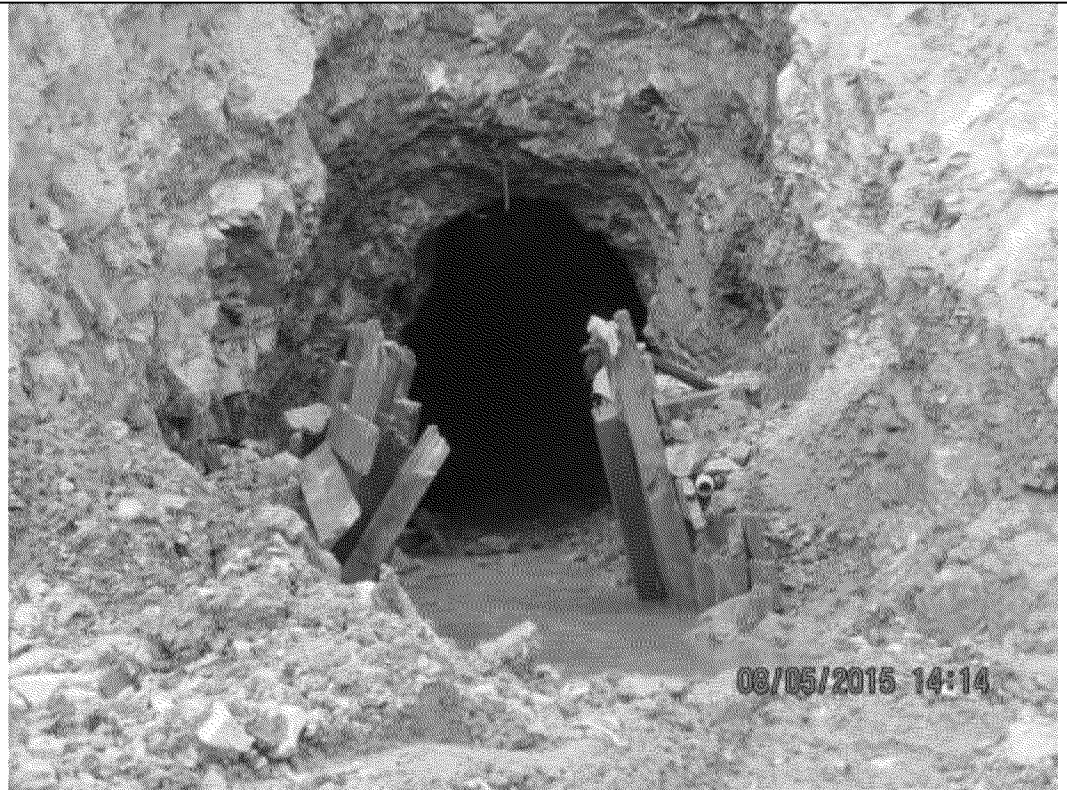
**Photo
No.
45**

Water levels lowering
at adit entrance, no
visible changes to
structure.

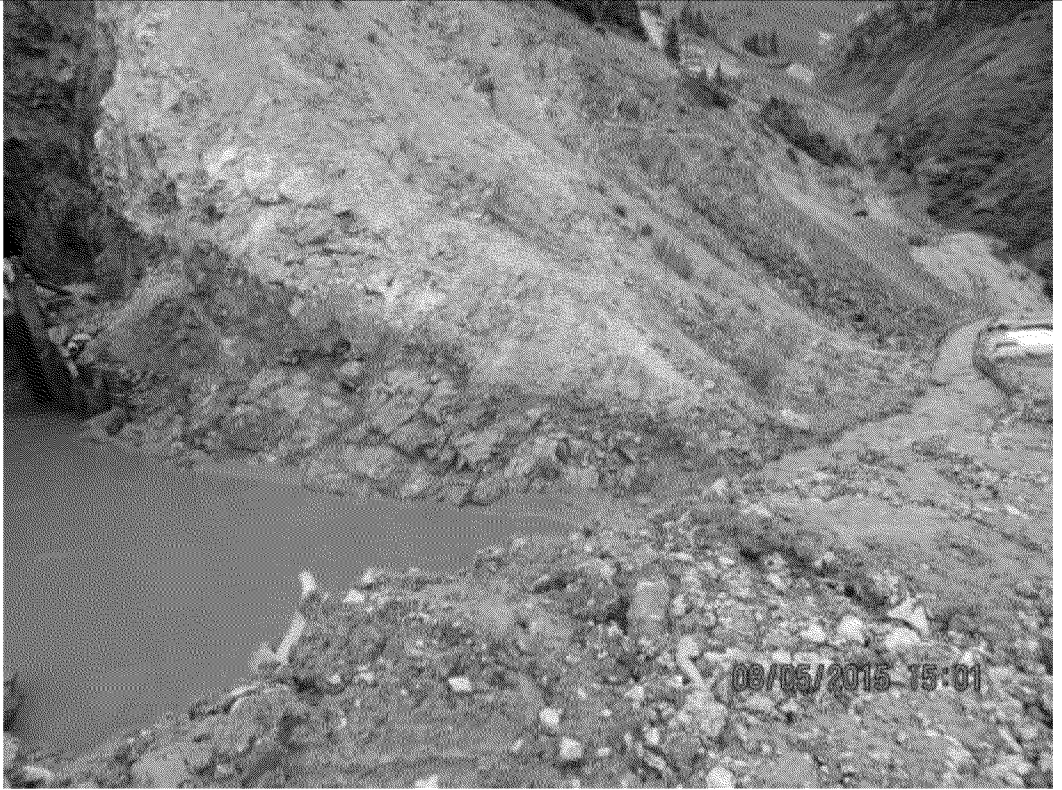
Direction Photo Taken: Northeast		
Description: Flow path from adit, water flow appears to have stabilized around 1400.

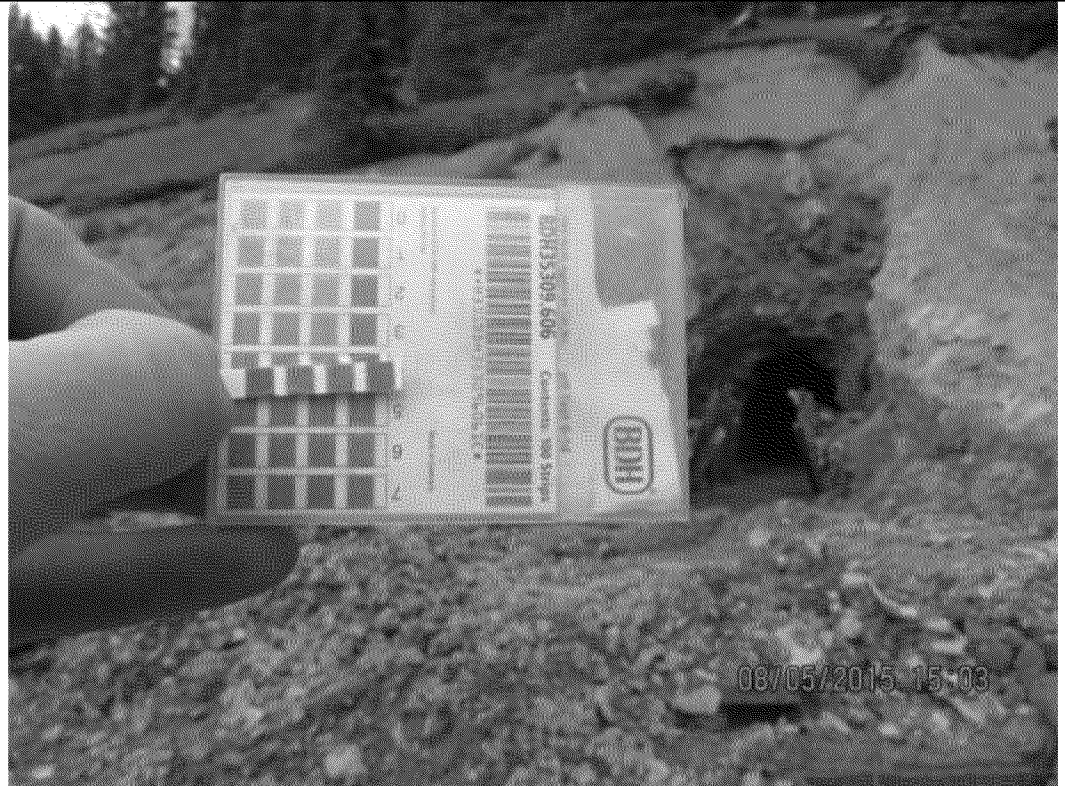
Photo No.
49

pH measured at approximately 4.5.

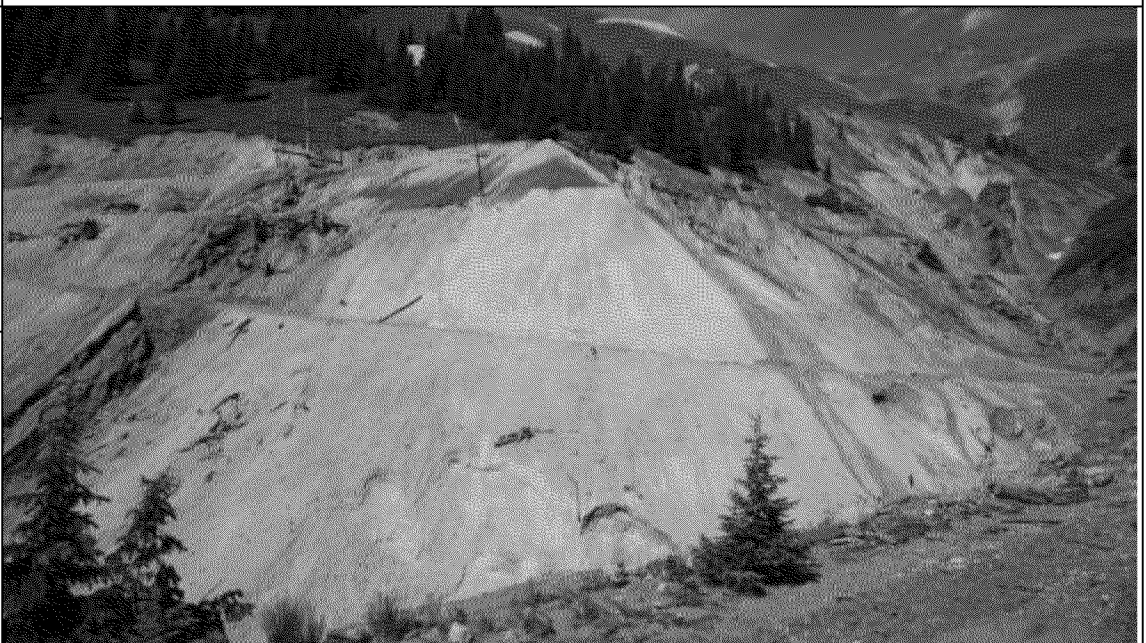
Direction Photo Taken: Northeast		
Description: Gold King Mine tailings dump after water discharge.
